Sherwood School District

# Facilities Planning and Assessment Report

by DOWA - IBI Group Architects, Inc. | August 2015

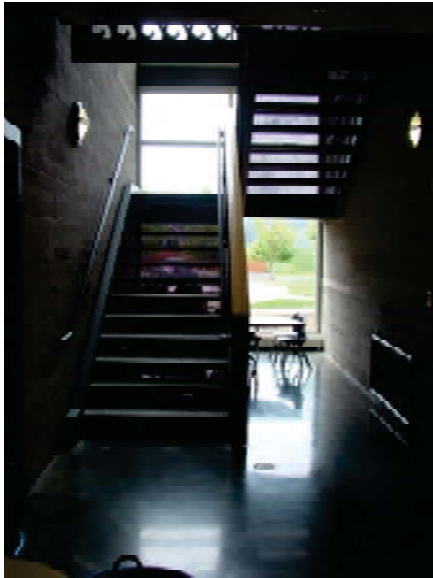
Figure B10.4 – Under Stair Use

<b>B - INTERIORS</b>			
<b>B10 – INTERIOR CIRCULATION</b>			
<b>Item</b>		<b>Findings</b>	<b>Comments</b>
B10.1	Construction and Exiting	<ul style="list-style-type: none"> <li>No issues observed</li> </ul>	<ul style="list-style-type: none"> <li>Building is fully sprinklered.</li> <li>Fire doors are present in select locations.</li> </ul>
B10.2	Stairs and Handrails	<ul style="list-style-type: none"> <li>No issues observed</li> </ul>	<ul style="list-style-type: none"> <li>Stairs and handrails are in very good condition.</li> </ul>
B10.3	Ramps and Elevators	<ul style="list-style-type: none"> <li>No issues observed</li> </ul>	<ul style="list-style-type: none"> <li>Portions of this building are 2-story, and an elevator is present (Schindler).</li> <li>A ramp provides an accessible route to Stage and in front of the Library.</li> </ul>
B10.4	Accessibility	<ul style="list-style-type: none"> <li>The permanent barriers designed at both classrooms stairs have been removed and the space under the stairs appears to be used for instruction. See Figure B10.4.</li> </ul>	<ul style="list-style-type: none"> <li>This may violate the reduced vertical clearance requirements stated in ANSI (American National Standards Institute) A117.1 Section 307.4.</li> </ul>

B10.5	Signage	<ul style="list-style-type: none"> <li>No issues observed</li> </ul>	
<b>RECOMMENDATIONS</b>			
B10.4 If current setup does not comply with ANSI requirements, reinstall barriers.			
<b>B20 – INTERIOR FINISHES</b>			
<b>Item</b>		<b>Findings</b>	<b>Comments</b>
B20.1	Flooring	<ul style="list-style-type: none"> <li>Thresholds/transition strips between flooring materials in several rooms has significant gaps.</li> </ul>	<ul style="list-style-type: none"> <li>The main flooring material is stained, polished concrete. Carpeting is present in select locations and in all classrooms and is in excellent condition.</li> <li>The Gymnasium has a wood floor.</li> <li>Kitchen flooring is quarry tile.</li> <li>It was noted there are areas of staining on the concrete floors and at drinking fountains. When the flooring receives new sealer, these areas should be attended to.</li> </ul>

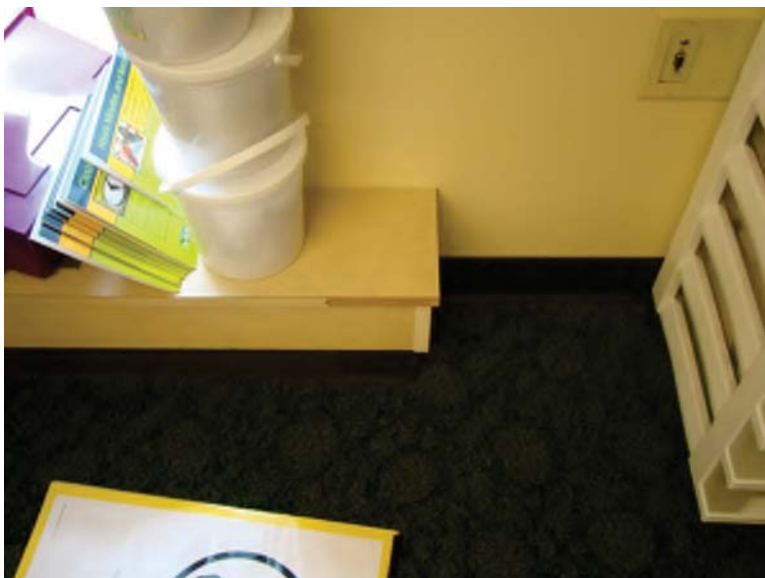
Figure B30.4 – Damaged Sill

Item	Findings	Comments
B30.1	Interior Windows	<ul style="list-style-type: none"> <li>No issues observed</li> </ul>
B30.2	Interior Doors and Hardware	<ul style="list-style-type: none"> <li>No issues observed</li> <li>Doors are wood with painted metal frames, and are generally in very good condition.</li> </ul>
B30.3	Acoustics	<ul style="list-style-type: none"> <li>No issues observed</li> </ul>
B30.4	Casework	<ul style="list-style-type: none"> <li>The plastic laminate sill in Room E9 was damaged. See Figure B30.4.</li> <li>All other casework is in excellent condition.</li> <li>Classroom sinks include</li> </ul>

B30.4	Replace damaged plastic laminate.		
-------	-----------------------------------	--	--

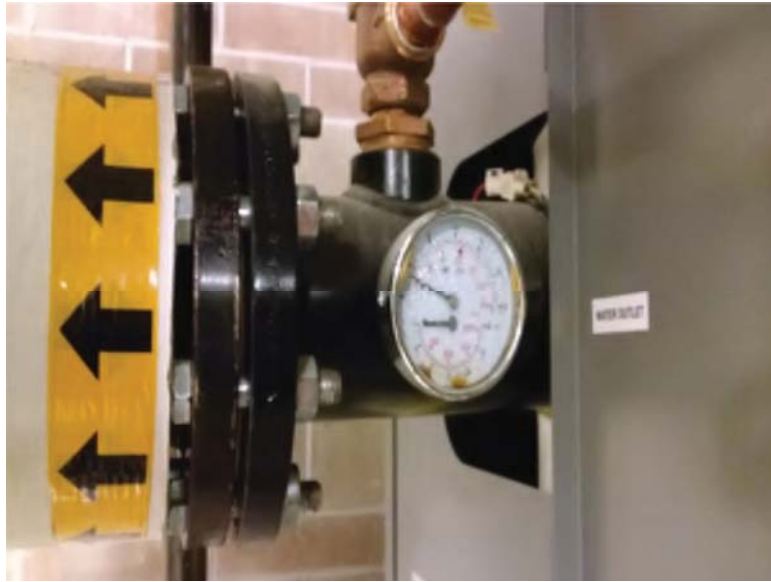
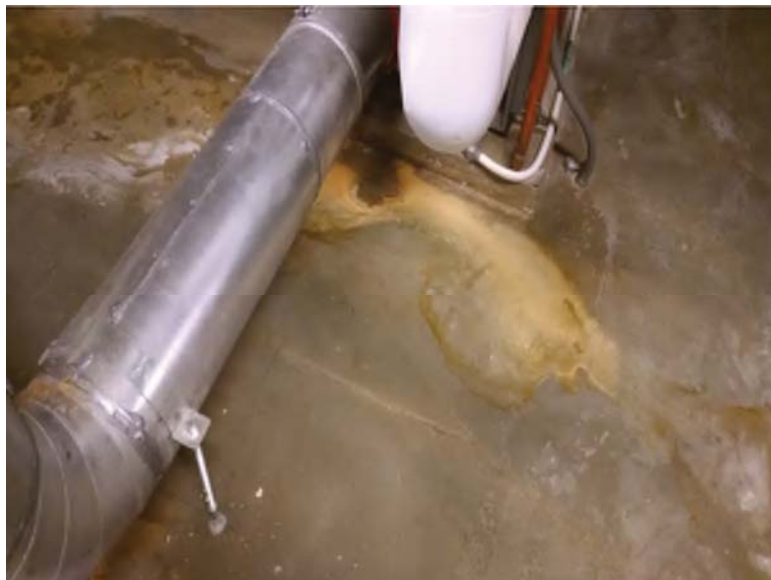
**Figure C20.10.a – Boiler**

C20.9	Heating Systems	<ul style="list-style-type: none"> <li>Corridor radiant heaters need floor support.</li> </ul>	<ul style="list-style-type: none"> <li>Central air handler units with hot water heating coils.</li> <li>VAV reheat coils are hot water.</li> <li>Hot water radiators present at perimeter of classrooms and corridors.</li> </ul>
C20.10	Boiler	<ul style="list-style-type: none"> <li>There is a leak at one boiler combination temperature / pressure gauge. See Figure C20.10.a.</li> <li>There are leaks at the boiler flue material joints. See Figure C20.10.b.</li> </ul>	<ul style="list-style-type: none"> <li>Condensing gas fired stainless steel are Aerco Benchmark units.</li> </ul>

- C20.4 Complete code analysis of building under new code to eliminate the need for some fire smoke dampers.
- C20.5 Remove lighting control system and place lights on BAS.
- C20.7 Install refrigerant line insulation protection.
- C20.9 Add floor supports to corridor radiators.
- C20.10 Replace gauge and stacks.

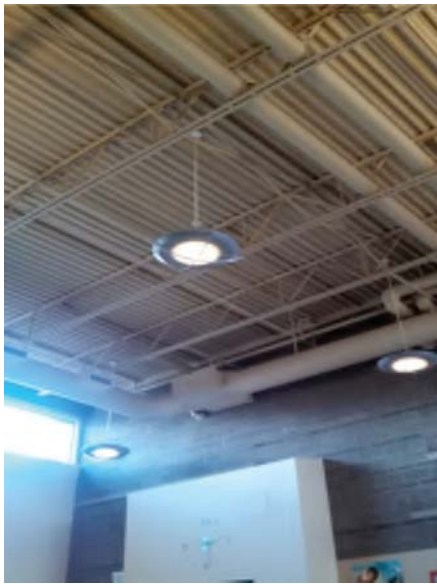
**Figure D10.3 – Lighting**

<b>D - ELECTRICAL</b>			
<b>D10 - ELECTRICAL EQUIPMENT</b>			
<b>Item</b>		<b>Findings</b>	<b>Comments</b>
D10.1	Transformers	<ul style="list-style-type: none"> <li>No issues observed</li> </ul>	
D10.2	Switchgear and Panelboards	<ul style="list-style-type: none"> <li>No issues observed</li> </ul>	<ul style="list-style-type: none"> <li>This is a recently constructed facility with sufficient expansion capability.</li> <li>Equipment is Square D.</li> </ul>
D10.3	Lighting	<ul style="list-style-type: none"> <li>Indirect lighting in cafeterias and media centers appears underlit. See Figure D10.3.</li> <li>Some fluorescent bulb types are hard to obtain.</li> </ul>	<ul style="list-style-type: none"> <li>Ceilings are not white in these locations.</li> </ul>
D10.4	Lighting Controls	<ul style="list-style-type: none"> <li>Maintenance personnel indicate programming is difficult.</li> </ul>	<ul style="list-style-type: none"> <li>Leviton lighting control panels are used in some areas.</li> </ul>

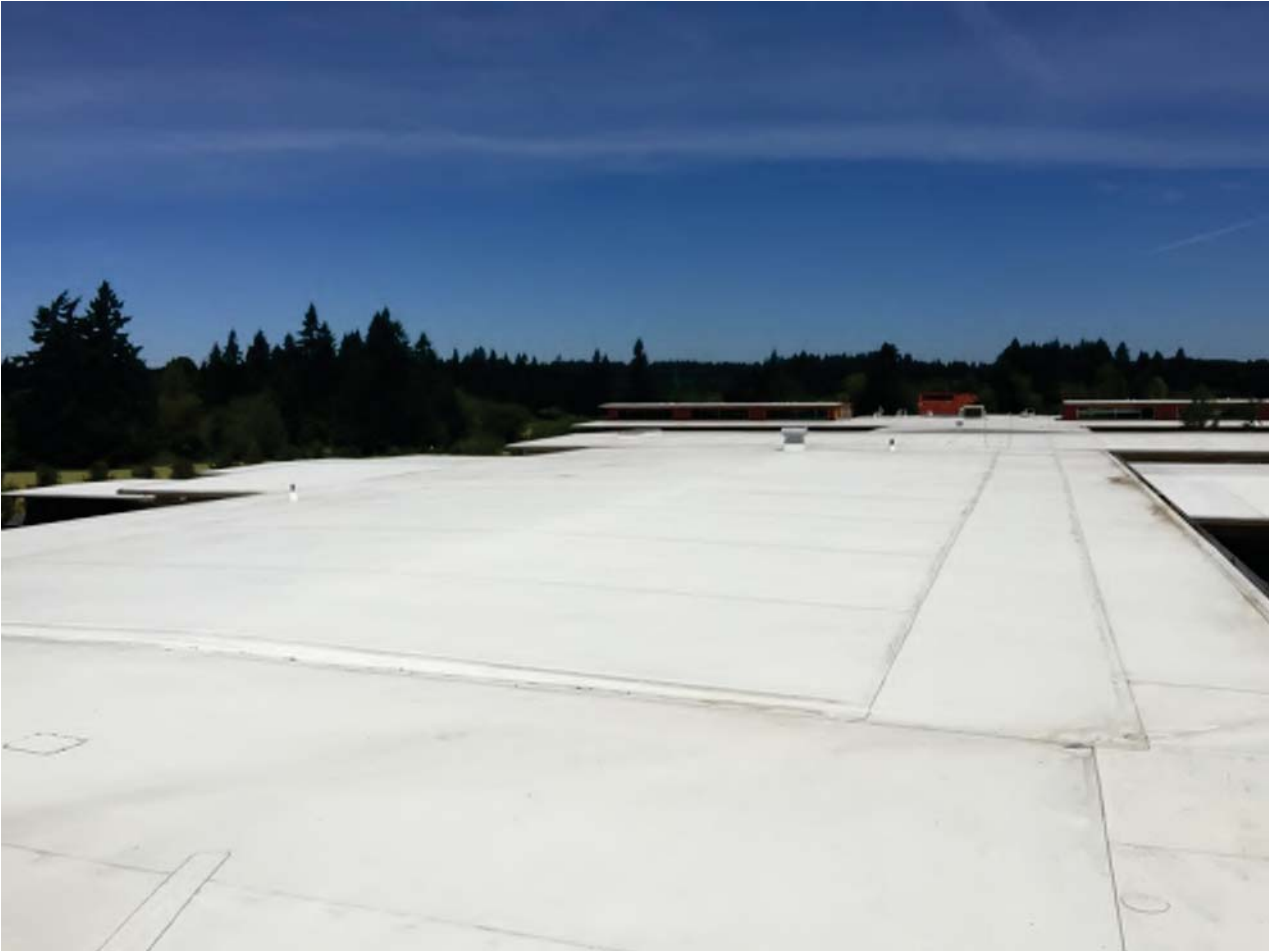
OPEN CLEAN ROOF WITH GOOD SLOPE

The school was constructed in 2008-2009 and is roofed with a GAF TPO membrane system that appears to be holding up well. A few minor leaks have occurred but have been dealt with via warranty. There are minimal roof penetrations and most roof areas drain well meaning this roof should reach its full life expectancy of 25 years meaning replacement should be scheduled in approximately 19 years or approximately in 2034.

Budget for Replacement of TPO Membrane in 19 years: \$ 750,000.00

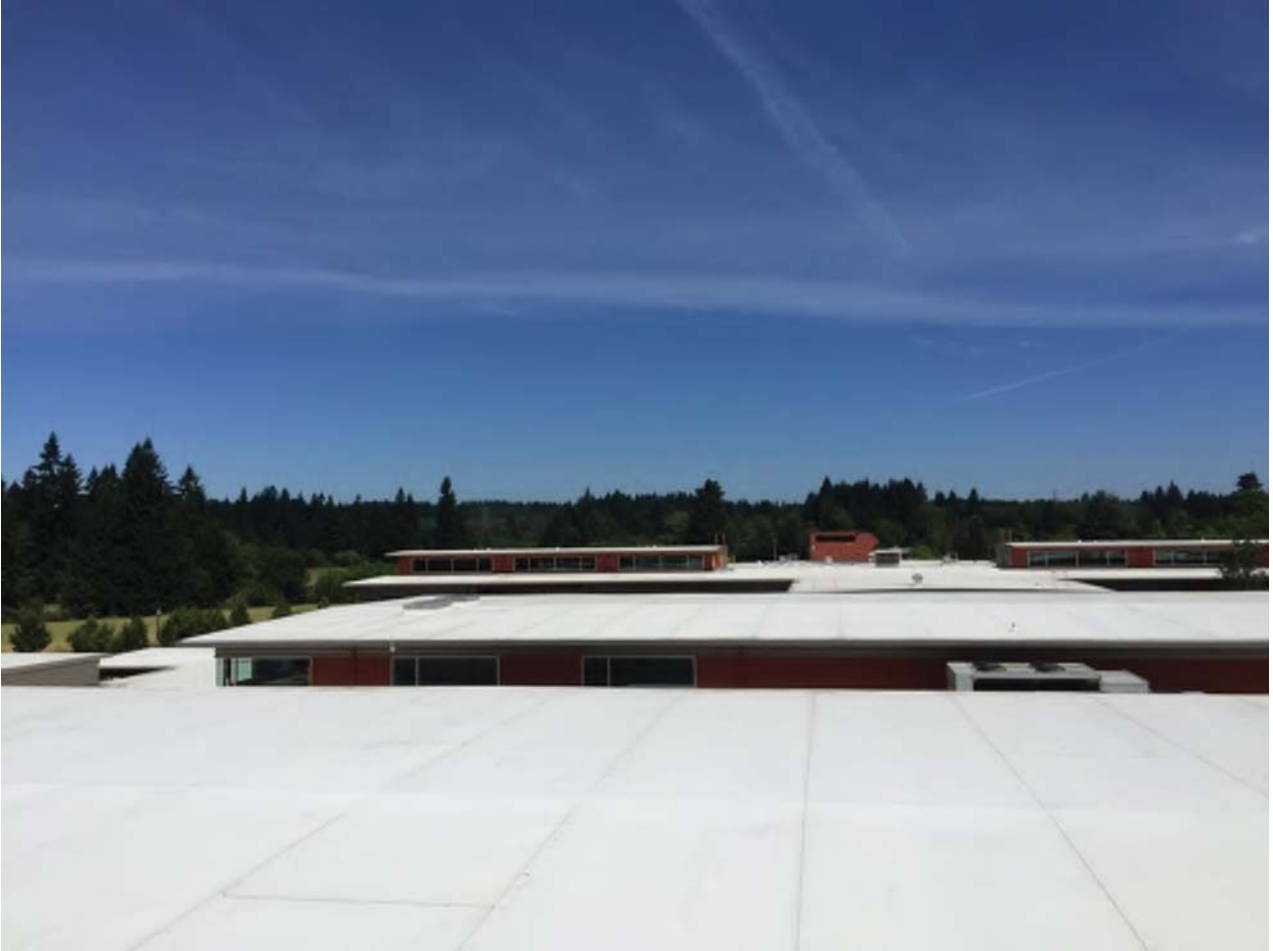
OPEN CLEAN ROOF WITH GOOD SLOPE

The school was constructed in 2008-2009 and is roofed with a GAF TPO membrane system that appears to be holding up well. A few minor leaks have occurred but have been dealt with via warranty. There are minimal roof penetrations and most roof areas drain well meaning this roof should reach its full life expectancy of 25 years meaning replacement should be scheduled in approximately 19 years or approximately in 2034.

Budget for Replacement of TPO Membrane in 19 years:   \$ 780,000.00
