Sherwood School District

# Facilities Planning and Assessment Report

by DOWA - IBI Group Architects, Inc. | August 2015

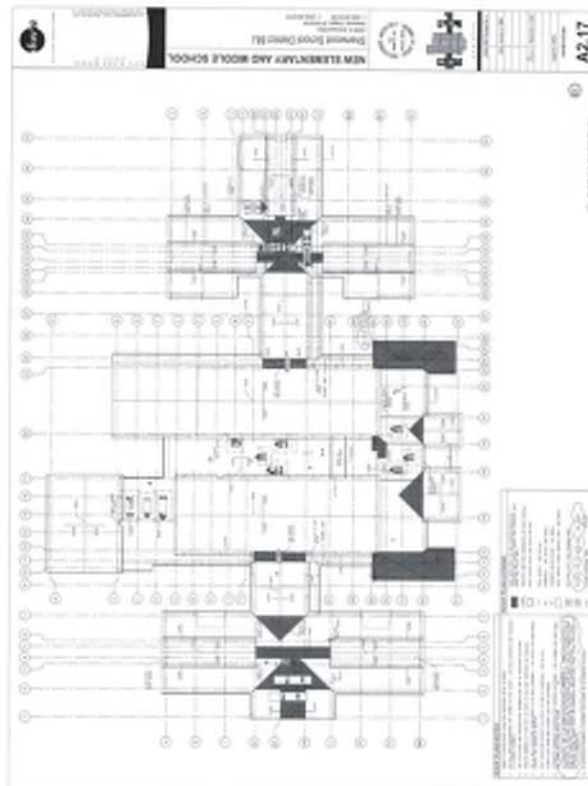
LAUREL RIDGE AND EDY RIDGE ROOF DIAGARM

The school was constructed in 2008-2009 and is roofed with a GAF TPO membrane system that appears to be holding up well. A few minor leaks have occurred but have been dealt with via warranty. There are minimal roof penetrations and most roof areas drain well meaning this roof should reach its full life expectancy of 25 years meaning replacement should be scheduled in approximately 19 years or approximately in 2034.

Budget for Replacement of TPO Membrane in 19 years: \$ 750,000.00

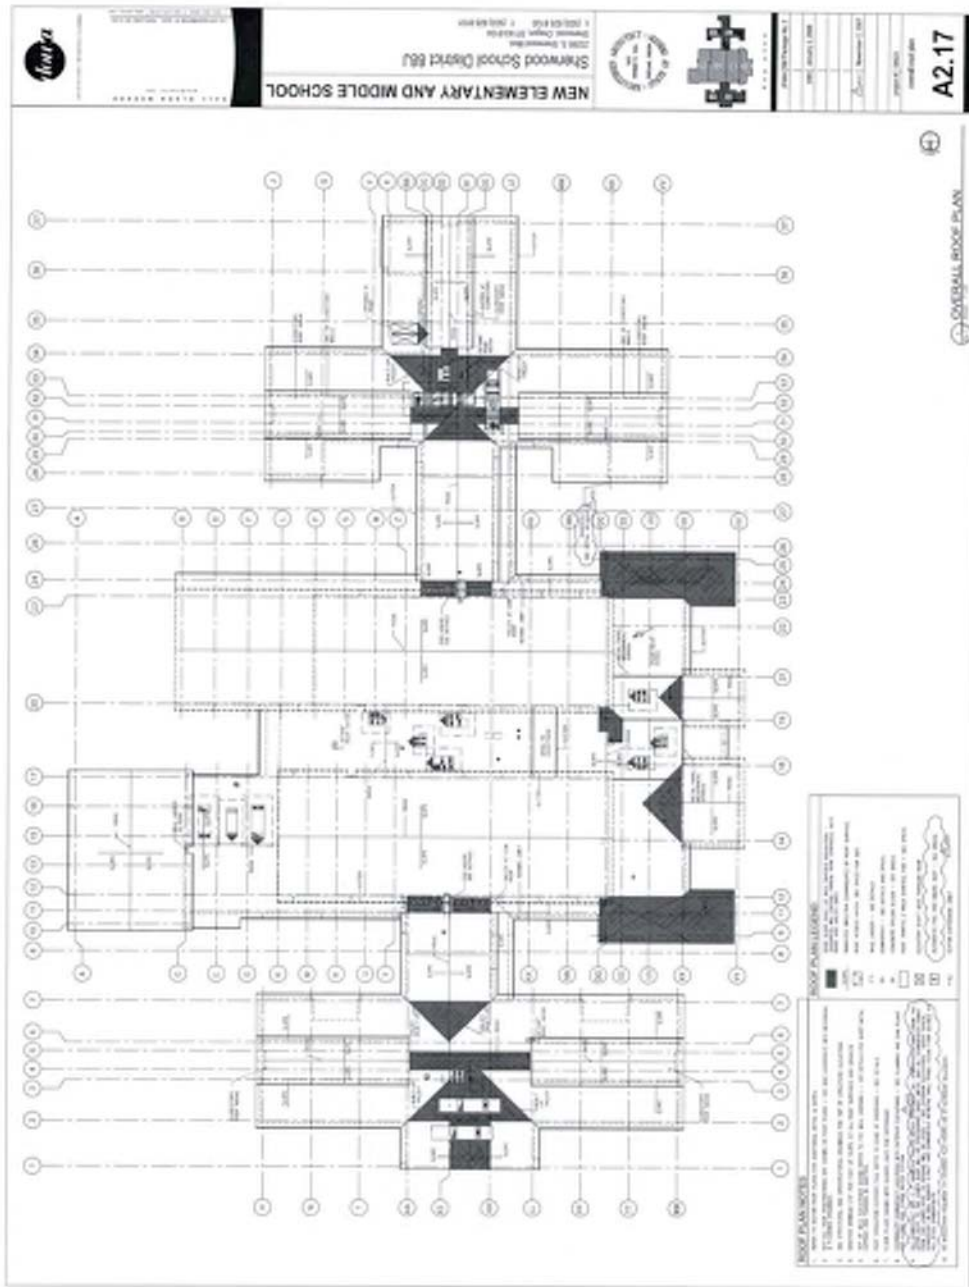
LAUREL RIDGE AND EDY RIDGE ROOF DIAGARM

The school was constructed in 2008-2009 and is roofed with a GAF TPO membrane system that appears to be holding up well. A few minor leaks have occurred but have been dealt with via warranty. There are minimal roof penetrations and most roof areas drain well meaning this roof should reach its full life expectancy of 25 years meaning replacement should be scheduled in approximately 19 years or approximately in 2034.

Budget for Replacement of TPO Membrane in 19 years:   \$ 780,000.00
